CASE STUDY

BURNT ASH PRIMARY SCHOOL

Burnt Ash Primary School Case Study

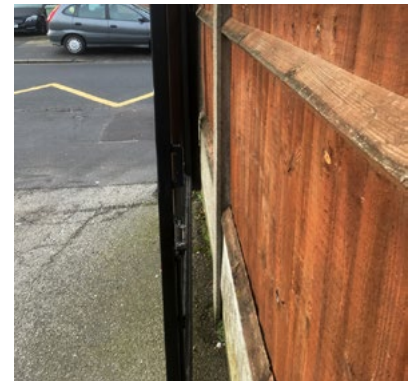
1. Risk of impact, trapping and crushing. Safety edges were only fitted horizontally to the bottom of the gate leaves on the inside of site. When tested, these edges only stopped the gates but did not revert. This represented a potential hazard since there was potential for a person to be pinned and trapped against the fence. (image 7789)

risk of gate crushing against a fence

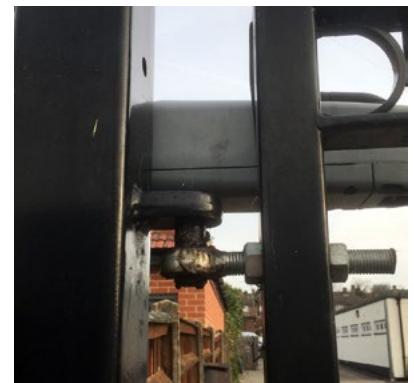
3. Risk of impact and crushing. Only two hinges per leaf were fitted, with the top hinges inverted. In the event of one hinge failing, the leaves could easily fall. The weight of the leaves is supported only by the bottom hinges as the top ones are inverted, resulting in an even greater possibility of a gate failure.

inverted hinge

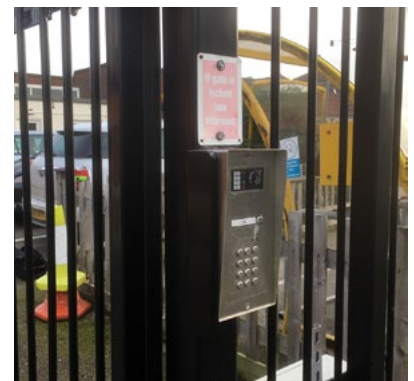
4. Risk of trapping and crushing. Large gaps were identified at hinges (over 100mm) which reduced substantially when the gates were opened. There was no evident sign of protection in this area which is subject to massive forces. The intercom outstation was mounted to the outside on the hang stile and was only reachable from the wrong side of the gates potentially causing someone to be in the most dangerous area.

reducing gap at the hinge

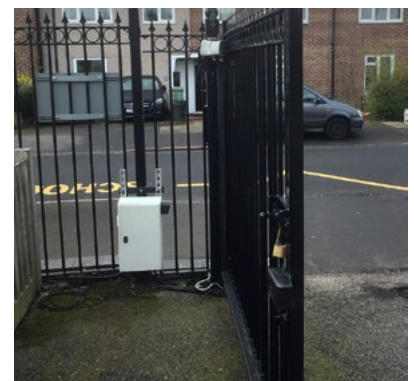
5. Risk of impact and crushing. No inside photocells were fitted to cover the arc of the gates.

gate features no inside photocells
